DAYSAILER TECHNICAL NOTE

D. J. Bents [From *The Day Sailer*, #100, Spring 1986]

DS II Center-board Trunk Leaks

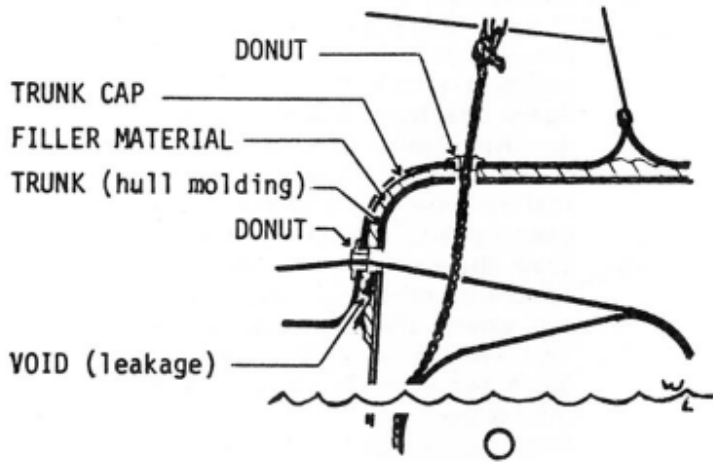
The problem is with the centerboard pendant through-holes which are drilled into the trunk from the cabin (one faces forward and has a stainless steel cable running through it; the other is on top).

The filler in this sandwich is a chopped fiber(glass) putty, used to cement the joints between the hull and cockpit moldings. During assembly, most of it gets squeezed out to fill voids when the moldings are pressed together. The pendant through-holes are drilled after this assembly step. If the voids were not completely filled in where the hole is drilled, or if the filler material has cracked and broken away from inside the hole, then there is a direct path for water to get in. The pendant holes themselves are pretty large — 3/4" — fortunately, they are located above the waterline. Nevertheless, water splashing up inside the confines of the centerboard trunk is under considerable surge pressure; it is literally pumped in by wave action through any opening that appears.

The forward (raising) pendant hole is the most likely place for this to occur since it is the lowest. Worse yet, the steel cable tends to cut into the surrounding material like a bandsaw, each time the board is raised. Over time, the hole will grow into an elongated slot; this only lets more water in.

How water gets in

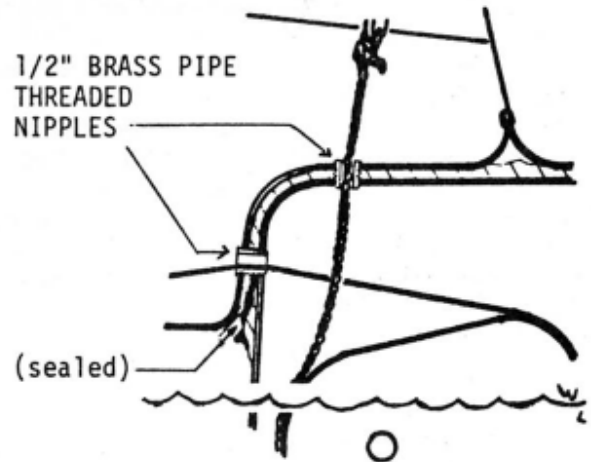
How to fix it

The problem can be fixed temporarily by jamming some filler putty inside the hole. Or, you can fix the problem for good simply by tapping out the holes and threading brass pipe nipples into them!

The factory-drilled pendant holes are only slightly larger than the starting diameter of a half-inch NPT pipe tap. The trick is to tap each hole only deep enough to thread the nipple all the way through the centerboard trunk, yet protrude no more than 1/8" or so into the interior cavity (to allow clearance for the board and pendants). The fiberglass taps easily and will hold a threaded joint that is strong and tight. The pipe nipple will reinforce the hole, stop the leakage and allow the cable to slide freely without sawing into anything. A swaged loop will pass through the diameter that remains without difficulty.

6. Tap out each hole with the pipe tap. Tap it out in several passes; taking care each time to stop and thread the nipple in to see how much further it needs to go. If the hole is very much off-center in the trunk, you may want to grind or file down the nipple end to match the trunk cavity's interior contour more closely. Brass is a very easy metal to work with, so don't let filing to match a contour scare you. You will have to go back underneath the boat many times to see where the nipple is emerging. Strong sunshine or a powerful drop light helps.
