DS II CENTERBOARD CONTROL FOR RACING

Wm. C. Waggoner

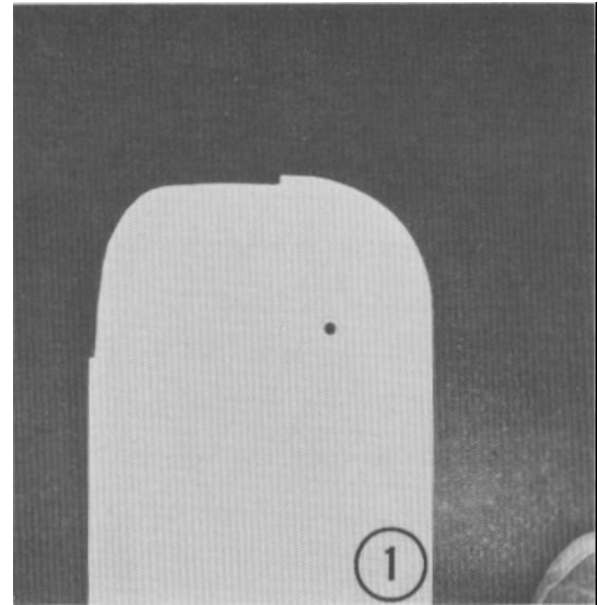
We first sought to secure the control wires to the board in a manner that the wires could be detached from the board and the blade removed from the hull for servicing. A recess (Fig. 1) was cut into the board to accommodate a bent-to-contour 12-inch piece of stainless track, whose fastener holes were natural orifices through which the two stainless flexible control wires (forward:

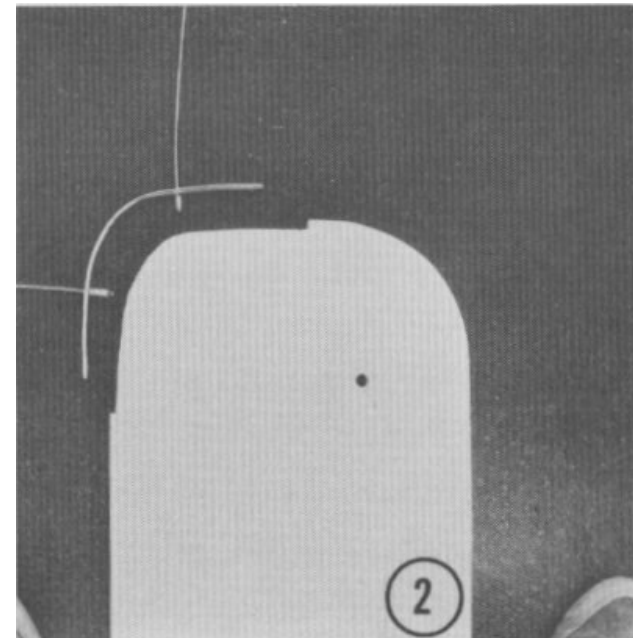
1/8", aft; 3/32") were led (Fig. 2). Holes (3/8") were countersunk in the board under each wire hole to accommodate the dead-ended wire sleeves (Fig. 3). The track groove formed a natural guide for the control wires during operation (Fig. 4). All stresses were shearing forces on the two stainless screws located at either end of the track. A 3/16" (1/2" long) aluminum pop-rivet in the center hole of the stainless track can act as an additional shearing fastener without crowding the track groove. After leading the 1/8" wire through the fore fairlead and the 3/32" wire through the aft centerboard pennant, the board was remounted in the slot with a small amount of lithium grease on the main bolt and Teflon bearing. The rubber gaskets were resealed with white silicone bathtub caulk.

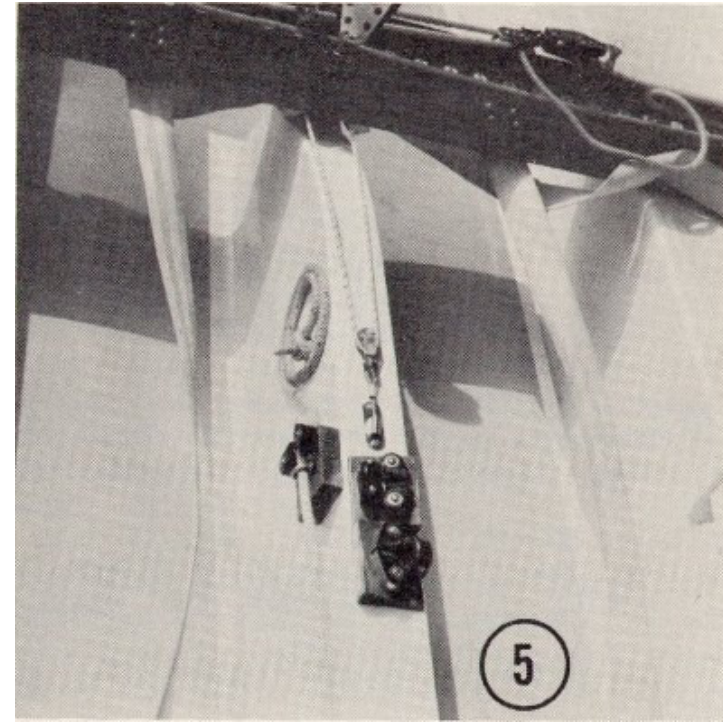
The aft 3/32" wire was measured with the board full up and the single bullet block was swaged on. The block was secured with shock cord into the tension system mounted under the thwart (Fig. 5). The tension system uses 1/4" or 5/16" shock cord lead through the four 1/4" cheek bullet blocks and secured with 1/4" clam cleats (Fig. 6).

- 8) if capsize occurs the shock cord tension will hold the board out of the trunk to make for easier righting of the craft.
